## Waste & Water Treatment

The City of Jacksonville chose Aerovent to upgrade its water production facilities and meet surging demands produced by wildfires and health department inspection requirements.

# CASE STUDY

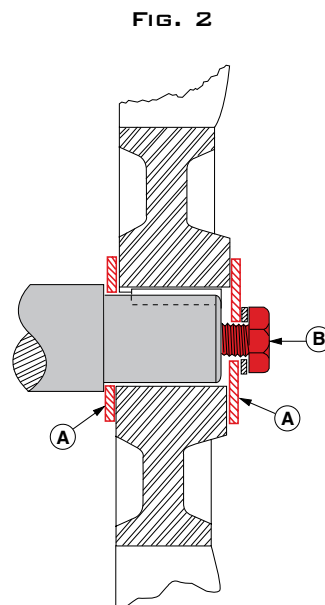
Aerovent’s engineering team designed a special insect-proof gasket arrangement to meet the first health department requirement (Figure 1). Aerovent’s fiberglass fans also meet rust specifications. Fans are molded and the structural integrity is achieved through extra thickness. The one-piece, solid FRP propeller is straight bored and keyed to a stepped 316 stainless steel shaft (Figure 2). Two Type 316 stainless steel collar washers and a 316 stainless steel bolt threaded into the end of the shaft to secure the propeller. This construction facilitates easy propeller removal for access to shaft seals and fan bearings. The shaft seals shown in Figure 3 isolate the bearings from the corrosive exhaust air and maintain “insect-proof” construction.

Referring again to Figure 2, two Type 316 stainless steel collar washers (A) and a 316 stainless steel bolt threaded into the end of the shaft secure the propeller (B). This type of construction ensures easy propeller removal for access to shaft seals and fan bearings.

- ▶ A water treatment facility must have easy access to the fan's propeller, shaft seals and bearings for maintenance and repair. Aerovent's stainless steel step shaft and retaining bolt ensure easy propeller removal for access to shaft seals and fan bearings.

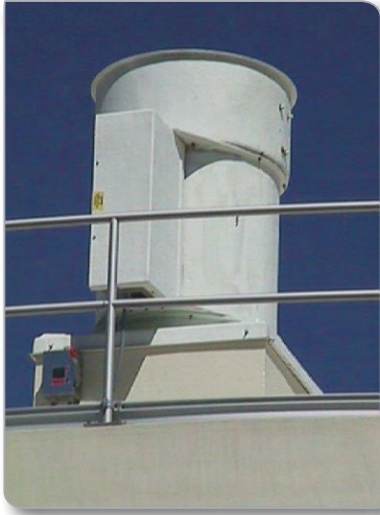
**MODEL TF**  
FIBERGLASS AXIAL FAN

Aerovent's 316 stainless steel motor bases are bolted between two integral FRP fan flanges to form a rigid structure. Fan motors are positioned and mounted for sheave and belt alignment. Belt tension is adjusted by loosening four bolts in slotted stainless steel bases. On larger horsepower motors (or where specified by the owner), 316 stainless steel NEMA motor slide bases are furnished to facilitate easy belt tensioning and replacement.

- ▶ Belt tensioning and alignment problems can occur with commercial manufacturer's construction. Aerovent's 316 stainless steel motor bases are bolted between fan flanges to form a rigid structure and facilitate easy belt tensioning and replacement.
