Fan Bearing Maintenance & Troubleshooting

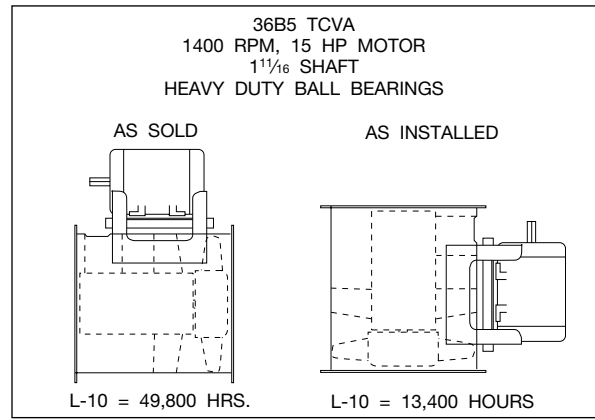
Fan orientation affects bearing life. A fan designed to operate with its shaft positioned horizontally will have a lower bearing life when positioned with a vertical shaft. This is due to the additional thrust loads put on the bearings from the shaft and impeller weight. Figure 3 shows an example. An axial fan designed for horizontal duty has an L-10 life of 49,800 hours. Tipping the fan so that the shaft is vertical lowers the bearing life to an unacceptable level of 13,400 hours. If a fan is to operate with a vertical shaft, make sure to order it for this orientation.

Figure 3. Effect of Shaft Position on Bearing Life

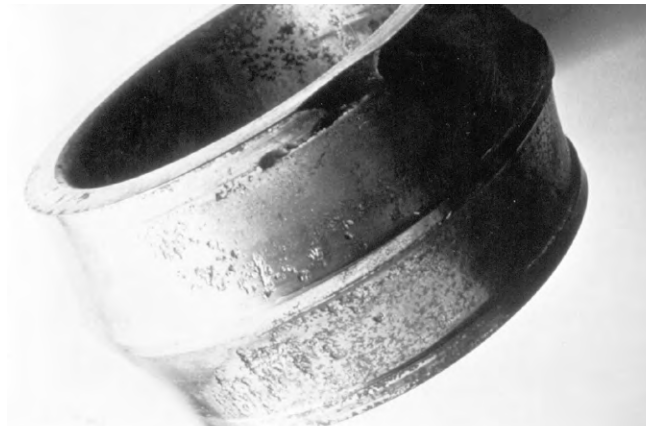
Figure 5 shows an inner race that has had a normal fatigue failure. The repeated loading and unloading of the race every time a roller passes eventually causes microscopic fatigue cracks to form under the surface.

In time, these cracks grow to the point where small portions of the surface flake off. This process is called "spalling" and the flaws left in the surface are called "spalls."

Figure 5. Normal Fatigue Failure

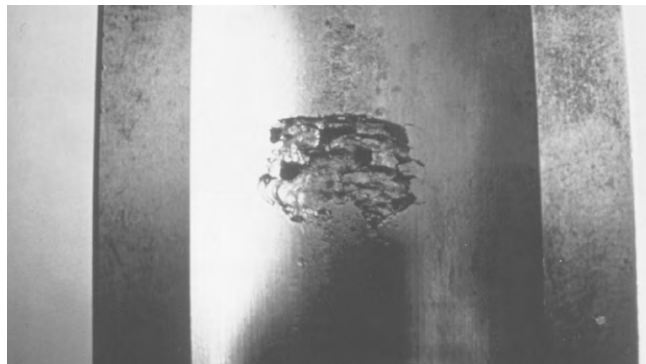
With continued operation, the spalls grow until the bearing becomes noticeably noisy. Figure 6 shows an inner race that has a severe spall. In addition to being noisy, it is also likely that this bearing would show high levels of vibration. The time required for the spalling to cause catastrophic bearing failure will vary with the load on the bearing and its speed. Usually the bearing will run for a while after it becomes noisy, but once noise is heard, prepare to have the bearing changed before it fails suddenly.

Figure 6. Spall

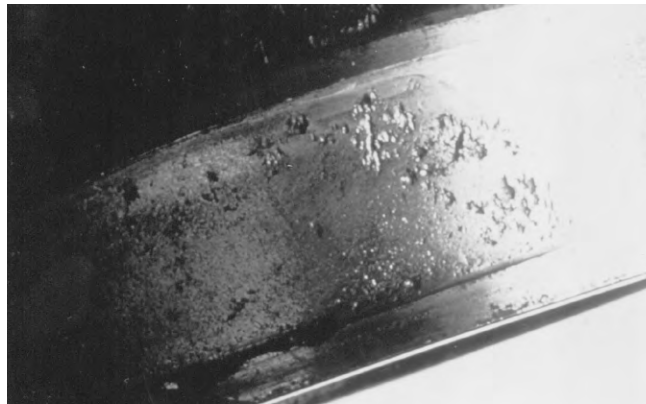
Inadequate lubrication can lead to spalling as seen in Figure 7. This bearing also shows signs of excessive

Figure 7. Spalls & Wear Patterns in the Race

wear due to inadequate lubrication. The rollers have worn a very deep wear pattern in the race.

Material that flakes out of spalls and other contaminants from other sources such as dirty grease or worn seals dents the races when caught between the rollers and races. Figure 13 shows an inner race with severe particle denting. Figure 7 also shows signs of particle denting. Each dent is a stress concentrator, which increases the stress in the area around the dent and accelerates the fatigue failure process.

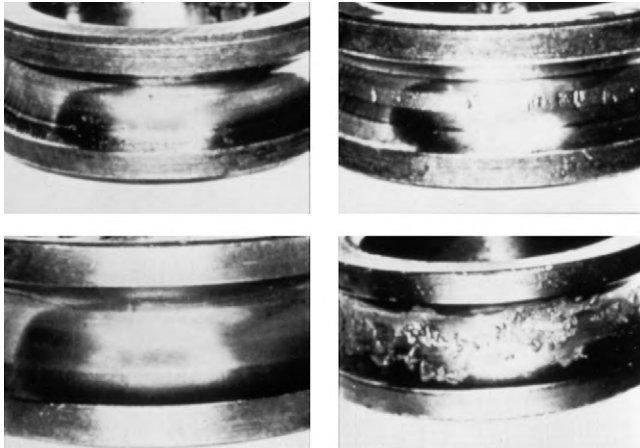
Figure 8 shows the progressive failure of a bearing due to inadequate lubrication. At first there are traces of waviness, or a slight roughening of the race. With time small cracks develop, which lead to a modest amount of spalls and eventually the severe amount of spalling shown on the lower right.

Figure 8. Progressive Failure of a Bearing Due to Inadequate Lubrication

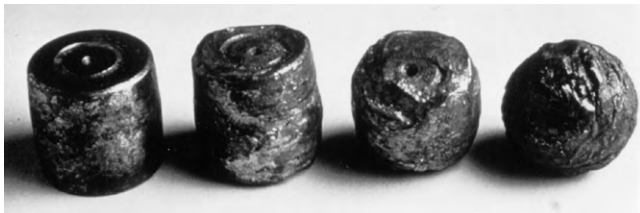
If the bearings continue to operate with inadequate lubrication, the evidence that shows this to be the mode of failure becomes destroyed. Notice how the spherical bearing rollers shown in Figure 9 become damaged with continued operation.

Figure 9. Damaged Spherical Bearing Rollers

If the bearing had been taken out of operation when the roller was in the condition shown on the left, it would be possible to determine the cause of failure. By the time the bearing completely failed, it had run so hot that the steel softened and the bearing became deformed. At this point it is impossible to tell what caused the initial failure. If you are having unexplained bearing failures, it is best to take the bearing out of service when you first notice noisy, hot, or vibrating operation. The evidence showing the initial cause of failure is probably still visible, and it will give you an idea as to what action to take to prevent additional failures.

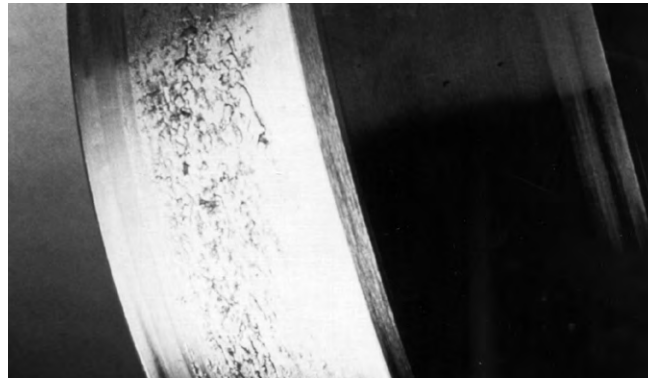
Under the right conditions the heat generated by metal-to-metal contact causes the two surfaces to adhere for an instant. Small portions tear out from one surface and adhere to the other surface. This is "smearing" and is shown in Figure 10.

Figure 10. Smearing

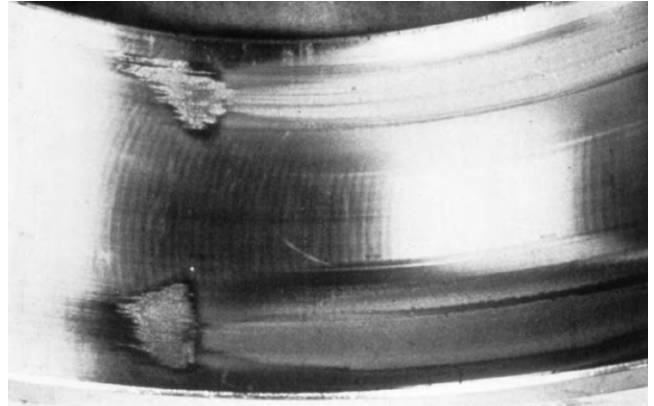
"Skid smearing," shown in Figure 11, occurs on lightly loaded bearings. As the rollers come around and enter the lower half of the bearing, they go from being

Figure 11. Skid Smearing

unloaded to being under load. With the light load it takes them some distance to roll properly, and they skid against the race causing smearing.

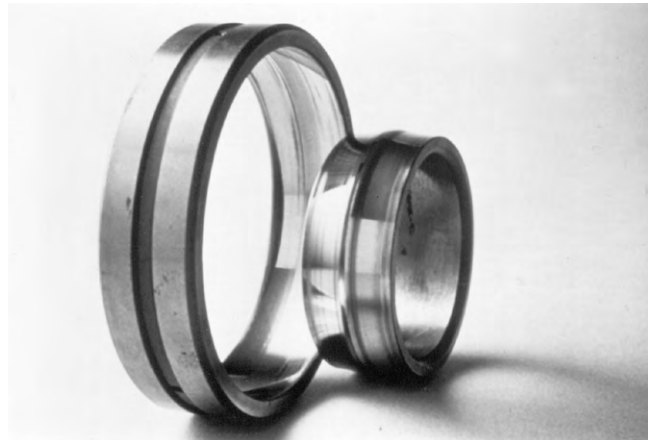
Figure 12. Highly Polished Surfaces Due to Inadequate Lubrication

Inadequate lubrication can sometimes cause the bearing surfaces to become highly polished as Figure 12 shows. Even though the surface looks nice, this is an indication of trouble. With continued operation the surface will change to a frosty appearance and eventually spall.

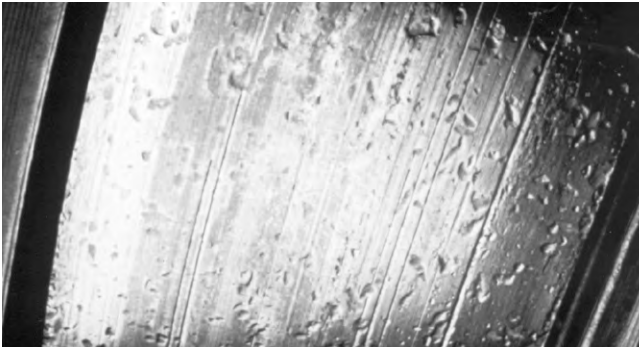
Figure 13. Severe Particle Denting

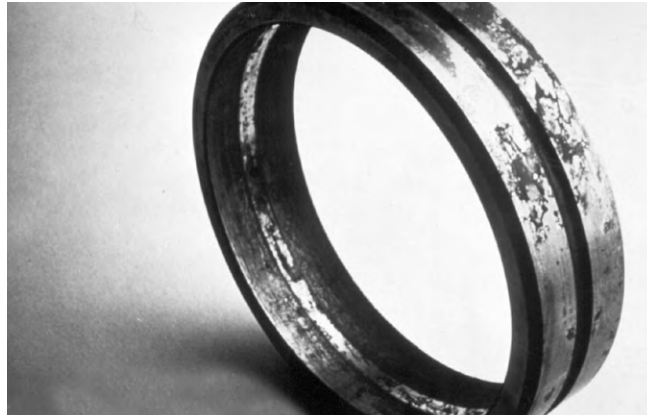
Keeping moisture out of bearings is necessary to achieve long life. Figure 14 shows a bearing severely damaged from water corrosion. This much damage was

probably due to seal failure, possibly in a “wash down” environment. High moisture applications require the use of grease that has rust inhibiting properties. Frequent relubrication is necessary, to insure that all bearing surfaces are coated with a protective layer of grease and that the rust inhibitors are replenished. Figure 15 shows a spherical roller bearing roller that has rusty ends from moisture in the lubricant.

Figure 14. Water Corrosion

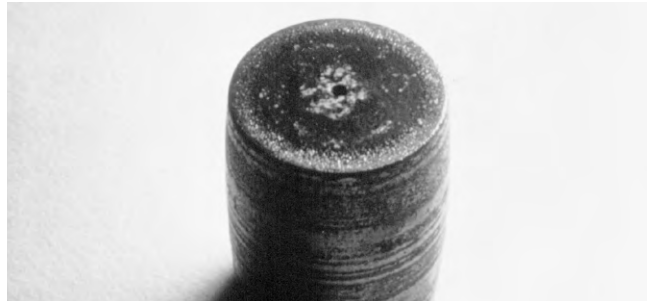
Figure 15. Bearing Roller with Rusty Ends Due to Moisture in the Lubricant

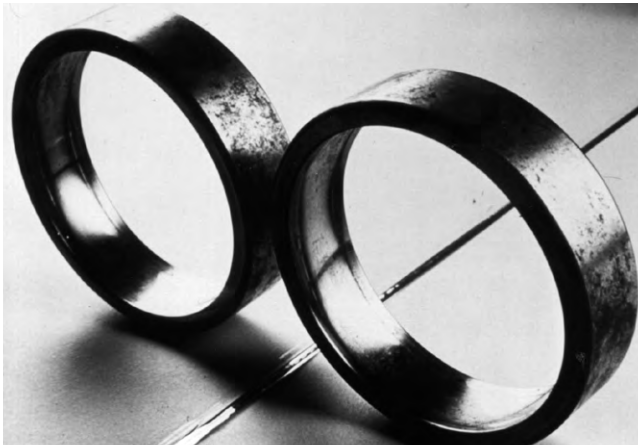
Mounting a bearing pillow block on a warped or crowned surface, or improperly shimming a pillow block can pinch the outer race. As seen in Figure 21, this causes two load zones on the outer race 180° apart.

As the rolling elements pass through the pinched area, the load between them and the races increases. If the severity of the pinch is high, a drastic reduction in the life of the bearing will result.

Figure 21. Two Load Zones on the Outer Race

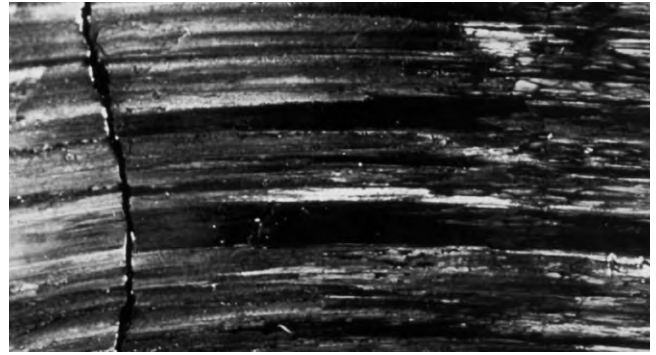
failures. Figure 22 shows the surface of a bearing bore that had too much clearance. The shaft turned in the bore, smearing the surface.

Insufficient tightening of the setscrews on a setscrew mounted bearing causes this type of failure. It can also be caused on a tapered adapter mounted bearing by not tightening the adapter lock nut enough. The damage to the surface resulted in a crack.

Figure 22. Smearing on a Bearing Race

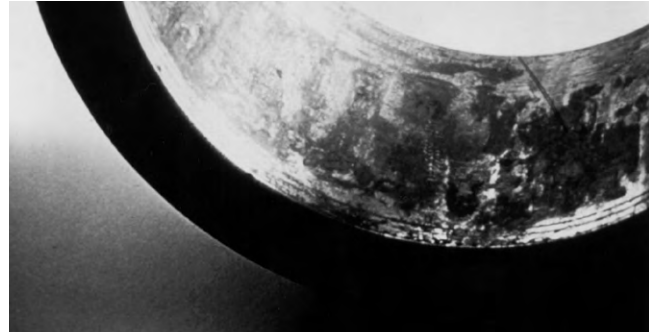
The bore of the bearing shown in Figure 23 shows signs of serious fretting corrosion. Microscopic movement between the shaft and the bore causes the rust colored patches to develop. Small amounts of fretting are common with setscrew mounted bearings and are not detrimental to bearing life. Advanced cases, caused by loose mounting, can lead to cracks.

Figure 23. Fretting Corrosion on Bearing Bore

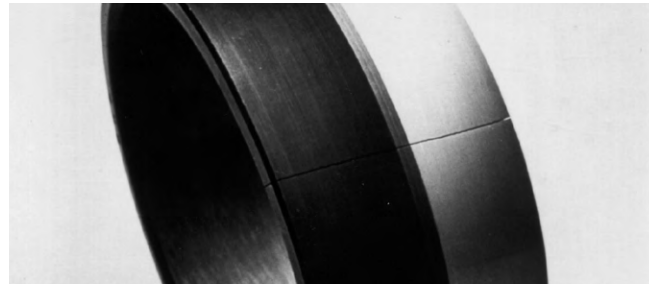
Tightening the locknut of an adapter mounted bearing too much can crack the inner race as shown in Figure 24, or the outer race as shown in Figure 25.

Figure 24. Cracked Inner Race

This also occurs by exposing the bearing on a high temperature fan to excessive temperatures. This easily happens when shutting down high temperature fans when they are hot, or by exposing them to high temperatures while idle.

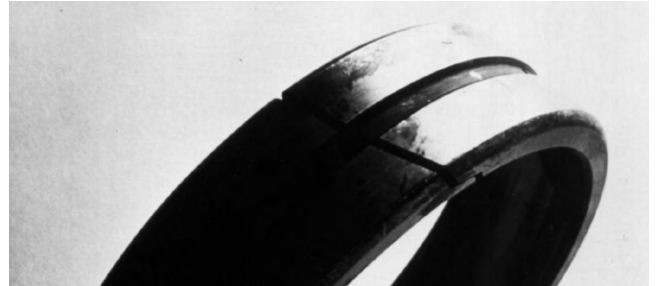
Figure 25. Cracked Outer Race

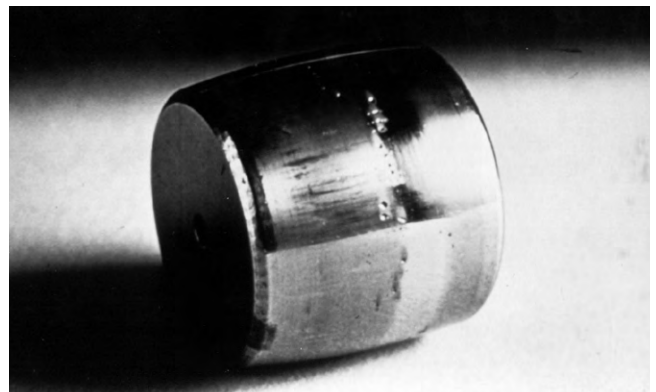
Figure 26. Pits Caused by Electrical Current

Allowing electrical current to pass through a bearing can cause damage. Figure 26 shows a spherical roller with pits in its surface caused by electrical current. This type of damage commonly occurs when welding balance weights on a fan wheel with improper grounding. To avoid having the welding electrical current pass through the bearings, attach the grounding clamp to the wheel or shaft when adding balance weights.
