## Variable Frequency Drive (VFD) Induced AC Motor Shaft Current and Bearing Damage

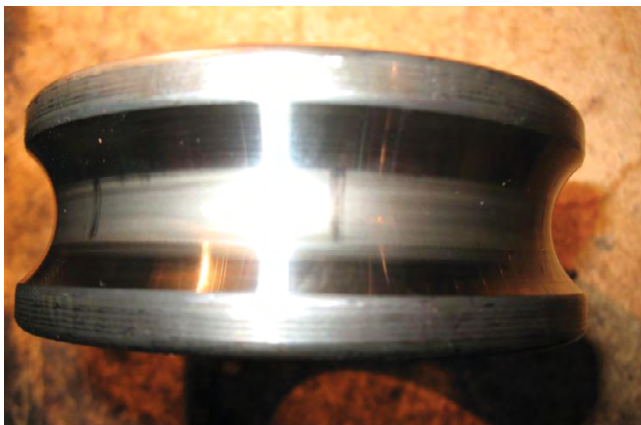
Figure 2. Bearing race exhibiting a "frosted" appearance.

In cases where induced shaft voltage exceeds the dielectric resistance of the bearing lubrication film, electric current will arc from the bearing ball or roller and raceway with sufficient amperage to create EDM pit. Due to the high frequency of the switching circuits, the electrical discharge arcs through the bearings can also occur at a high frequency. Even after a short period of time, the entire bearing race will become coated with small EDM pits. The inside surface of the bearing race will take on a "frosted" appearance. Eventually the bearing race will become severely pitted and fluted. Excessive noise and eventual bearing failure are the end results. Motor bearing failures have been documented after as little as a few months of operation. The majority of motor bearings that experience this issue will fail after 3 to 12 months of operation.

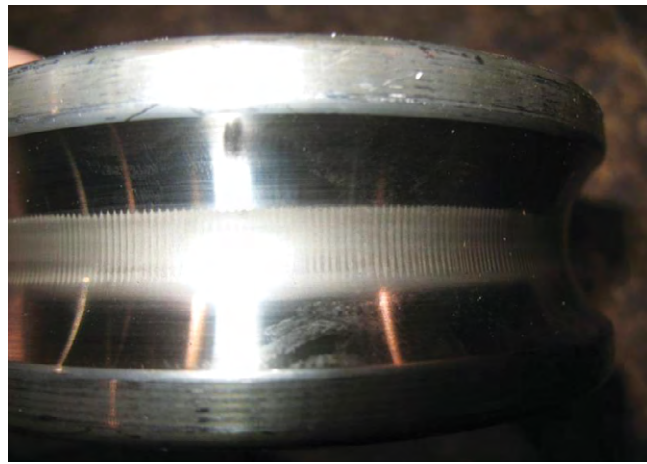
Figure 3. Bearing race exhibiting "fluting".

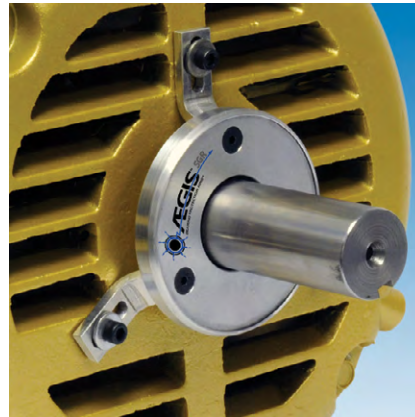
Figure 5. Externally mounting shaft grounding ring.

motor shaft), shaft grounding protects the motor against static electricity generated by the fan wheel. Grounding brushes have been proven to be effective, but require maintenance and are prone to failure due to wear. More recently, the shaft grounding ring (SGR) has been developed. The shaft grounding ring contains conductive microfibers that provide more points for conduction and are more durable than conventional brush fibers. A shaft grounding kit utilizing a shaft grounding ring can be installed to the motor shaft, grounding the motor shaft to the frame. Some AC motors may be purchased with shaft grounding rings pre-installed. In order for the shaft grounding ring to function effectively, the shaft must be cleaned before installation in order to ensure proper conductivity between the shaft and the grounding ring. Also, the motor must not be idle for an extended period of time as this may allow rust to build up on the shaft, causing the grounding ring to be ineffective. Internal installation is available on some motors, providing a cleaner environment and protection from damage for the shaft grounding ring. If the shaft is clean and free of rust, the combination of a shaft grounding ring and an insulated non-drive-end bearing provides excellent protection against EDM damage to bearings.
