## Fan Bearing Maintenance & Troubleshooting

## Bearing Failures and Their Causes

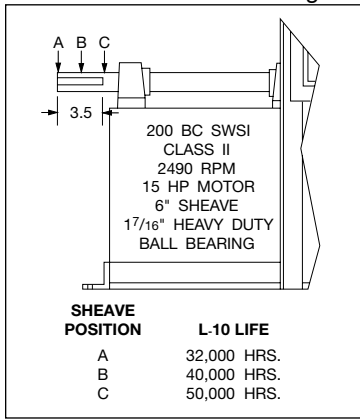
Figure 1. Effect of Sheave Location on Bearing Life

Figure 1 shows a typical fan selected to use a sheave with a six inch diameter on the fan shaft. With the sheave mounted at the end of the shaft, as far away from the bearing as possible, the L-10 life calculates to be 32,000 hours. (See FE-1200 for an explanation of L-10 life.) By moving the sheave 1.25" closer to the bearing, the life is increased to 40,000 hours. When the sheave is moved in another 1.25" so that it is as close to the bearing as possible, the life increases to 50,000 hours. The lesson learned by this example is to maximize bearing life by mounting the sheave as close to the bearing as possible.

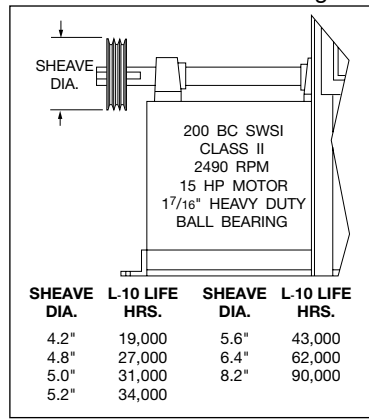
Figure 2. Effect of Sheave Diameter on Bearing Life

Most belt drives are selected using computer programs. The user puts in the information and the computer selects several sheave and belt combinations that will work, and usually highlights the least expensive. But the combination selected has a significant effect on bearing life. Large sheaves result in less belt pull and longer bearing life. Figure 2 shows the L-10 life for different fan sheave diameters. All of them are viable drive selections. The L-10 life varies from 19,000 hours with a 4.2 inch diameter sheave, to 90,000 hours with an 8.2 inch diameter sheave. Avoid the selections with the smallest sheave sizes. They are probably not the least expensive anyway since they require more belts. The best drive selection is one with a reasonable sheave size and moderate cost.

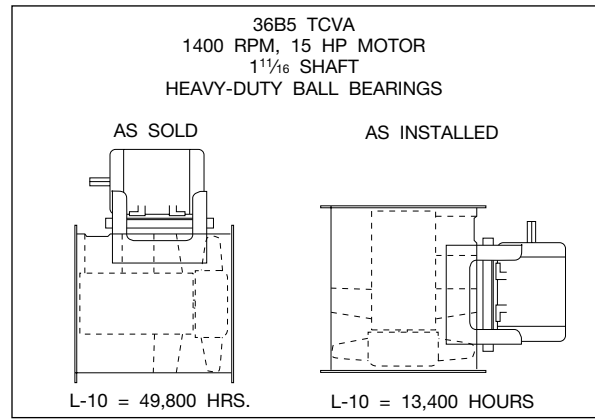
Figure 3. Effect of Shaft Position on Bearing Life

Fan orientation affects bearing life. A fan designed to operate with its shaft positioned horizontally will have a lower bearing life when positioned with a vertical shaft. This is due to the additional thrust loads put on the bearings from the shaft and impeller weight. Figure 3 shows an example. An axial fan designed for horizontal duty has an L-10 life of 49,800 hours. Tipping the fan so that the shaft is vertical lowers the bearing life to an unacceptable level of 13,400 hours. If a fan is to operate with a vertical shaft, make sure to order it for this orientation.

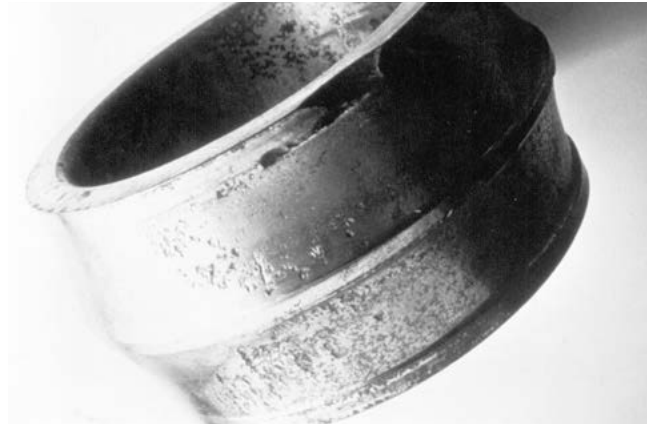
Figure 5. Normal Fatigue Failure

Figure 5 shows an inner race that has had a normal fatigue failure. The repeated loading and unloading of the race every time a roller passes eventually causes microscopic fatigue cracks to form under the surface.

In time, these cracks grow to the point where small portions of the surface flake off. This process is called "spalling" and the flaws left in the surface are called "spalls."

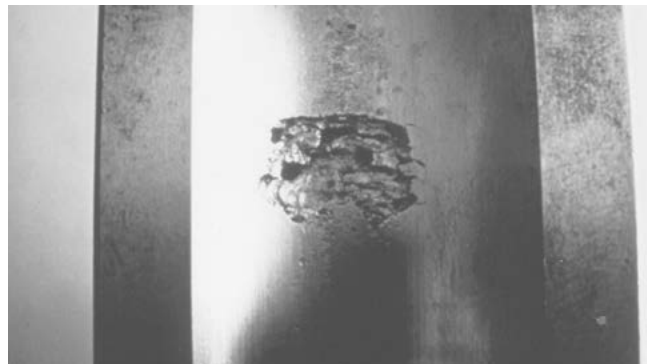
Figure 6. Spall

With continued operation, the spalls grow until the bearing becomes noticeably noisy. Figure 6 shows an inner race that has a severe spall. In addition to being noisy, it is also likely that this bearing would show high levels of vibration. The time required for the spalling to cause catastrophic bearing failure will vary with the load on the bearing and its speed. Usually the bearing will run for a while after it becomes noisy, but once noise is heard, prepare to have the bearing changed before it fails suddenly.

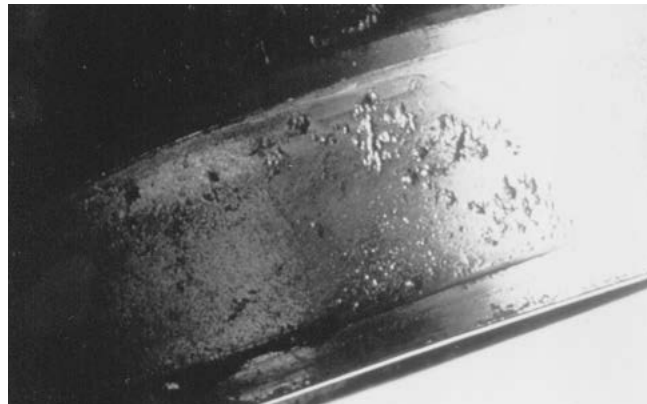
Figure 7. Spalls & Wear Patterns in the Race

Inadequate lubrication can lead to spalling as seen in Figure 7. This bearing also shows signs of excessive

wear due to inadequate lubrication. The rollers have worn a very deep wear pattern in the race.

Material that flakes out of spalls and other contaminants from other sources such as dirty grease or worn seals dents the races when caught between the rollers and races. Figure 13 shows an inner race with severe particle denting. Figure 7 also shows signs of particle denting. Each dent is a stress concentrator, which increases the stress in the area around the dent and accelerates the fatigue failure process.

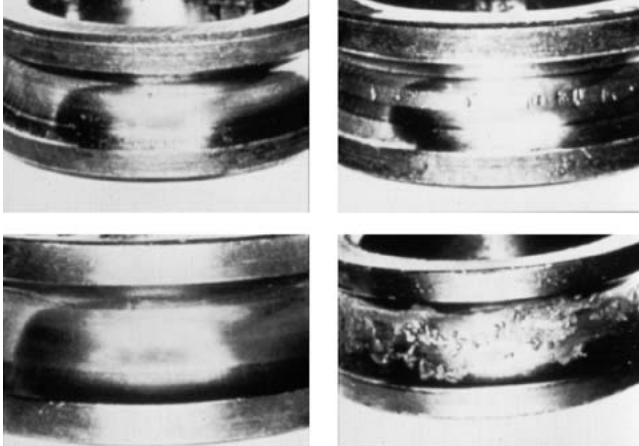
Figure 8. Progressive Failure of a Bearing Due to Inadequate Lubrication

Figure 8 shows the progressive failure of a bearing due to inadequate lubrication. At first there are traces of waviness or a slight roughening of the race. With time small cracks develop, which lead to a modest amount of spalls and eventually the severe amount of spalling shown on the lower right.

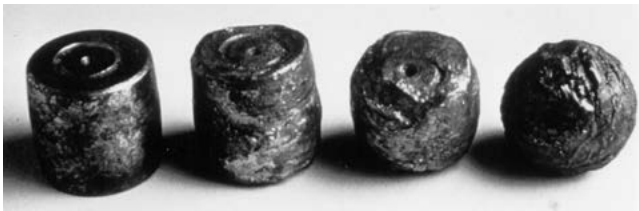
Figure 9. Damaged Spherical Bearing Rollers

If the bearings continue to operate with inadequate lubrication, the evidence that shows this to be the mode of failure becomes destroyed. Notice how the spherical bearing rollers shown in Figure 9 become damaged with continued operation.

If the bearing had been taken out of operation when the roller was in the condition shown on the left, it would be possible to determine the cause of failure. By the time the bearing completely failed, it had run so hot that the steel softened and the bearing became deformed. At this point it is impossible to tell what caused the initial failure. If you are having unexplained bearing failures, it is best to take the bearing out of service when you first notice noisy, hot or vibrating operation. The evidence showing the initial cause of failure is probably still visible and it will give you an idea as to what action to take to prevent additional failures.

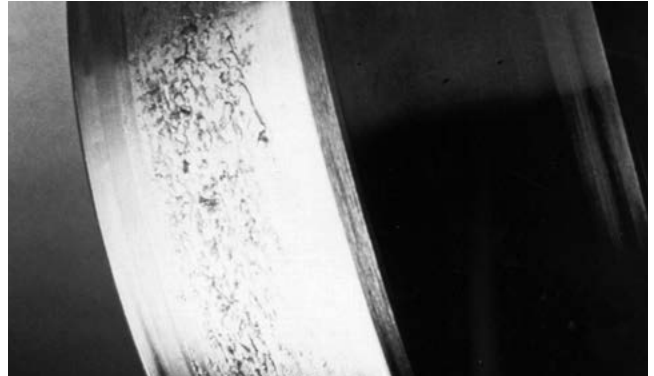
Figure 10. Smearing

Under the right conditions the heat generated by metal-to-metal contact causes the two surfaces to adhere for an instant. Small portions tear out from one surface and adhere to the other surface. This is "smearing" and is shown in Figure 10.

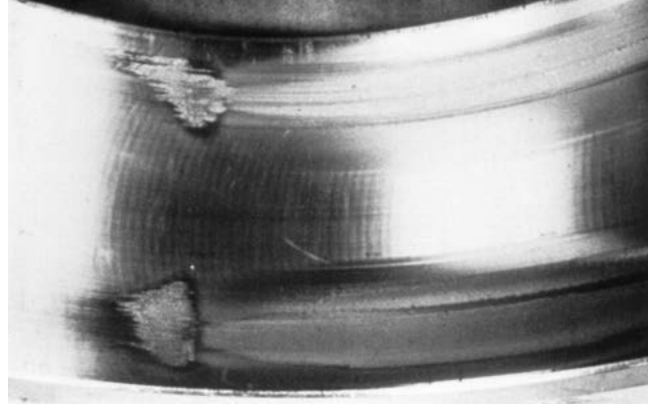
Figure 11. Skid Smearing

"Skid smearing," shown in Figure 11, occurs on lightly loaded bearings. As the rollers come around and enter the lower half of the bearing, they go from being

unloaded to being under load. With the light load it takes them some distance to roll properly and they skid against the race causing smearing.

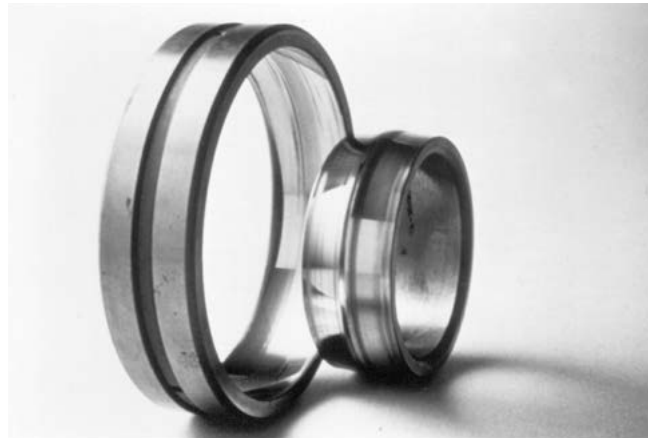
Figure 12. Highly Polished Surfaces Due to Inadequate Lubrication

Inadequate lubrication can sometimes cause the bearing surfaces to become highly polished as Figure 12 shows. Even though the surface looks nice, this is an indication of trouble. With continued operation the surface will change to a frosty appearance and eventually spall.

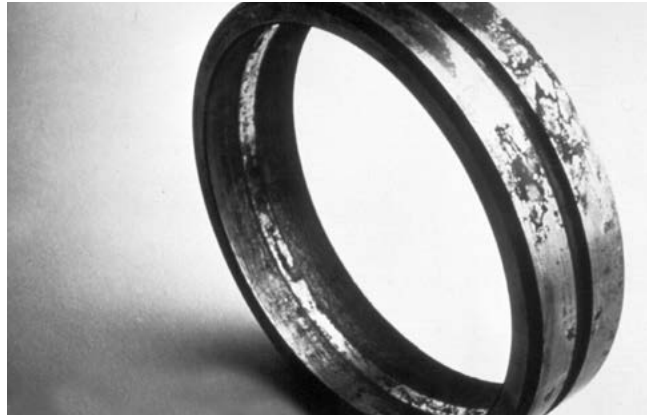
Figure 14. Water Corrosion

Keeping moisture out of bearings is necessary to achieve long life. Figure 14 shows a bearing severely damaged from water corrosion. This much damage was

probably due to seal failure, possibly in a “wash down” environment. High moisture applications require the use of grease that has rust inhibiting properties. Frequent relubrication is necessary, to insure that all bearing surfaces are coated with a protective layer of grease and that the rust inhibitors are replenished. Figure 15 shows a spherical roller bearing roller that has rusty ends from moisture in the lubricant.

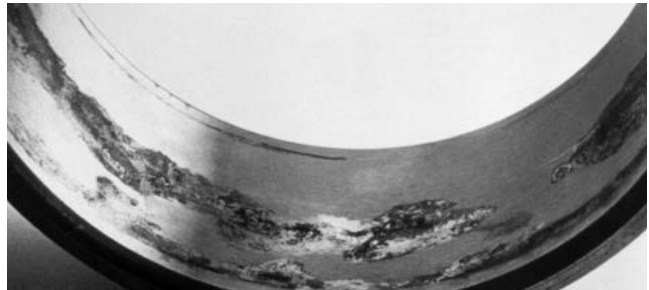
Figure 16. Puddle Corrosion

Water from condensation causes corrosion in idle fans. This is particularly true for fans in high moisture areas, located outdoors or improperly stored outdoors. Figure 16 shows an outer race damaged by puddle corrosion. Moisture or dew condensing in the bearing settles to the bottom of the race in puddles and causes rusting. Aerovent packs ball and unit roller bearings completely full of grease prior to shipment. Split pillow block spherical roller bearings are shipped with the bearing insert packed full. This minimizes the chances of having puddle corrosion occur during shipment and storage. This practice covers all components with grease and ensures there are no pockets of air where water can condense. At startup the excess grease purges out of the bearing, which gets a little messy but is better than having a damaged bearing.

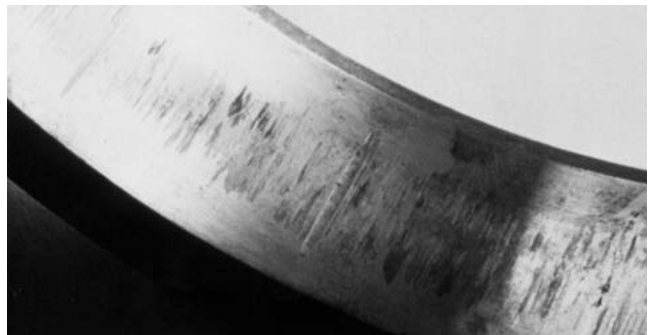
Figure 17. False Brinnelling

Figure 17 shows damage to an outer race from a bearing subjected to vibration while the unit is not rotating. Notice the even spacing of the marks, which correspond to the roller spacing. You can also see marks where the rollers came to rest in different locations. This type of damage, called “false brinnelling,” occurs when small portions of the race get rubbed away. The remaining area is ideal for starting fatigue and the abrasive material rubbed off contaminates the grease, which accelerates bearing wear.

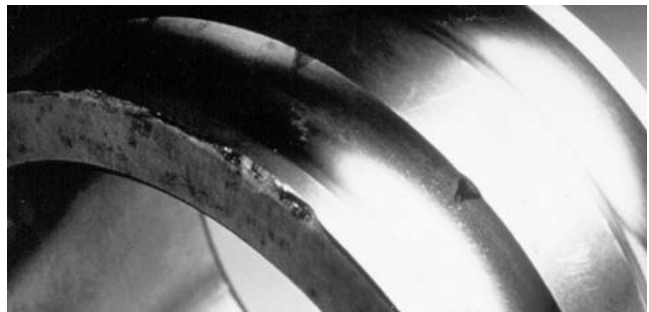
Figure 18. True Brinnelling

“True brinnelling” occurs when a bearing is subjected to impact and the rollers dent the races. Figures 18 and 19 show damage caused by improper mounting. Impact from hammering on the outer race or the bearing housing causes true brinnelling of the races. If it is necessary to tap on a bearing to get it into position, tap on the inner race so that the rolling elements do not carry the load. Dropping a bearing prior to mounting can also cause true brinnelling. Like false brinnelling, the marks are evenly spaced and the damage will eventually develop into spalls. Figure 20 shows spalls resulting from true brinnelling.

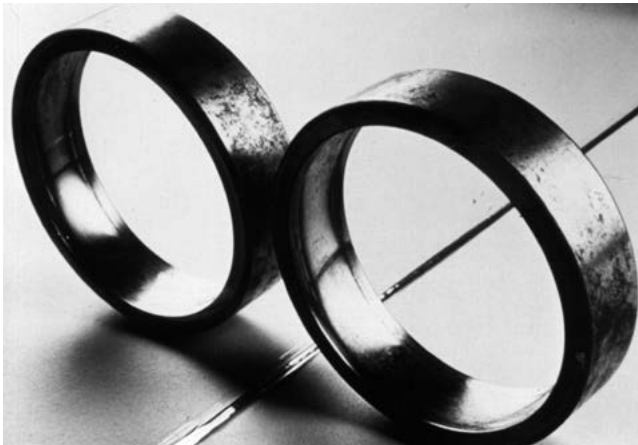
Figure 21. Two Load Zones on the Outer Race

Mounting a bearing pillow block on a warped or crowned surface, or improperly shimming a pillow block can pinch the outer race. As seen in Figure 21, this causes two load zones on the outer race 180° apart.

As the rolling elements pass through the pinched area, the load between them and the races increases. If the severity of the pinch is high, a drastic reduction in the life of the bearing will result.

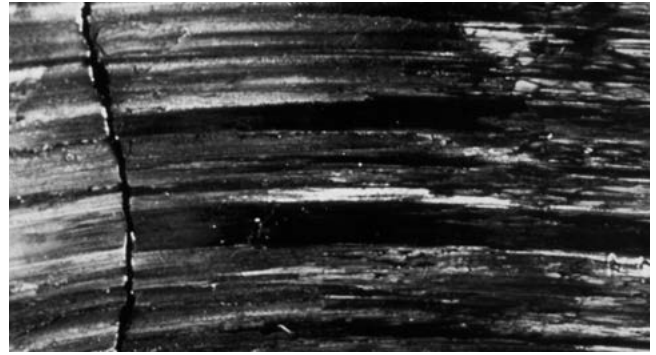
Figure 22. Smearing on a Bearing Race

failures. Figure 22 shows the surface of a bearing bore that had too much clearance. The shaft turned in the bore, smearing the surface.

Insufficient tightening of the set screws on a set screw mounted bearing causes this type of failure. It can also be caused on a tapered adapter mounted bearing by not tightening the adapter lock nut enough. The damage to the surface resulted in a crack.

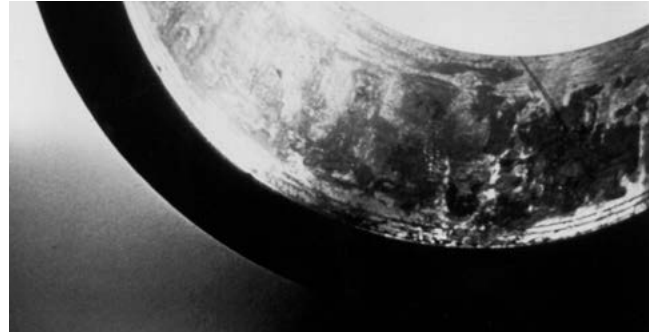
Figure 23. Fretting Corrosion on Bearing Bore

The bore of the bearing shown in Figure 23 shows signs of serious fretting corrosion. Microscopic movement between the shaft and the bore causes the rust colored patches to develop. Small amounts of fretting are common with set screw mounted bearings and are not detrimental to bearing life. Advanced cases, caused by loose mounting, can lead to cracks.

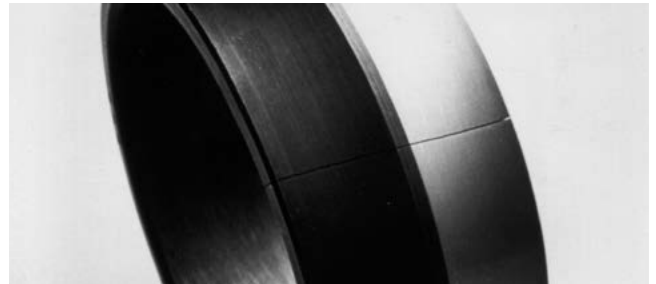
Figure 24. Cracked Inner Race

Tightening the locknut of an adapter mounted bearing too much can crack the inner race as shown in Figure 24 or the outer race as shown in Figure 25.

This also occurs by exposing the bearing on a high temperature fan to excessive temperatures. This easily happens when shutting down high temperature fans when they are hot or by exposing them to high temperatures while idle.

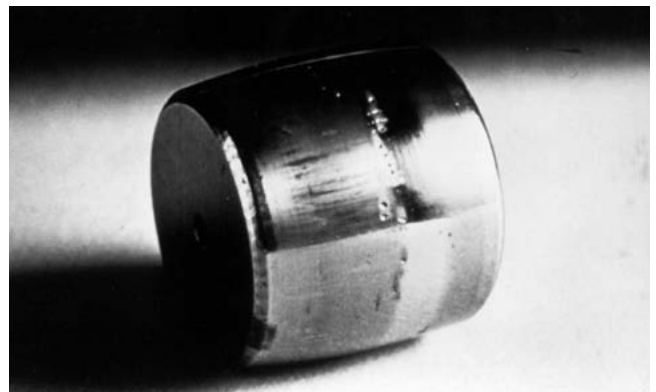
Figure 26. Pits Caused By Electrical Current

Allowing electrical current to pass through a bearing can cause damage. Figure 26 shows a spherical roller with pits in its surface caused by electrical current. This type of damage commonly occurs when welding balance weights on a fan impeller with improper grounding. To avoid having the welding electrical current pass through the bearings, attach the grounding clamp to the impeller or shaft when adding balance weights.
