Variable Frequency Drive (VFD) Induced AC Motor Shaft Current and Bearing Damage

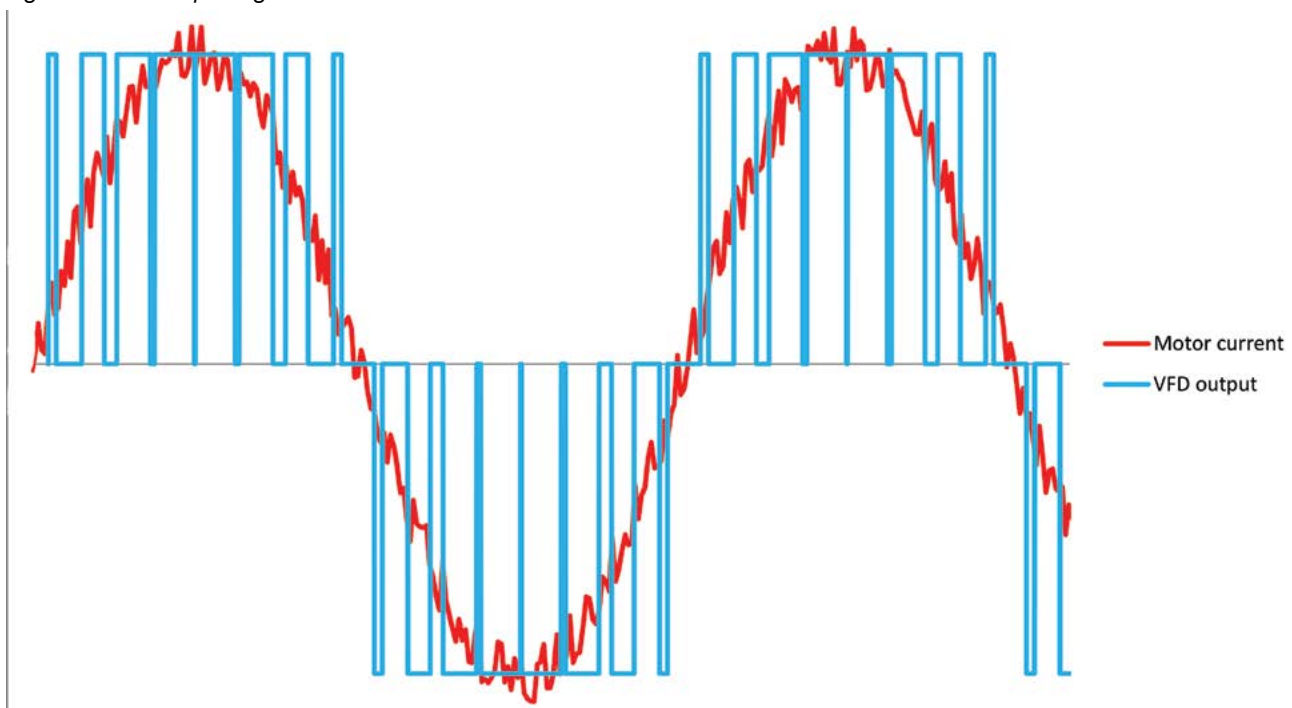
Figure 1. VFD output signal and motor current.

- The AC voltage signal is converted to DC voltage.
- IGBT's (insulated gate bipolar transistors) provide high-frequency switching.
- DC voltage is converted into a pseudo AC signal with variable frequency by voltage inversion and pulse width modulation (see Figure 1).

The frequency of the electrical pulses generating this signal is in the range of 1 to 20 kHz.
